**STATE OF TENNESSEE
DEPARTMENT OF LABOR AND WORKFORCE DEVELOPMENT
DIVISION OF BOILER AND ELEVATOR INSPECTION**

**Boiler Accident
Dana Corporation, Paris Extrusion Plant
Paris, Tennessee
June 18, 2007**

Report Date: July 9, 2007

**Report Prepared by:
Chief Boiler Inspector
Division of Boiler and Elevator Inspection
Tennessee Department of Labor and Workforce Development**

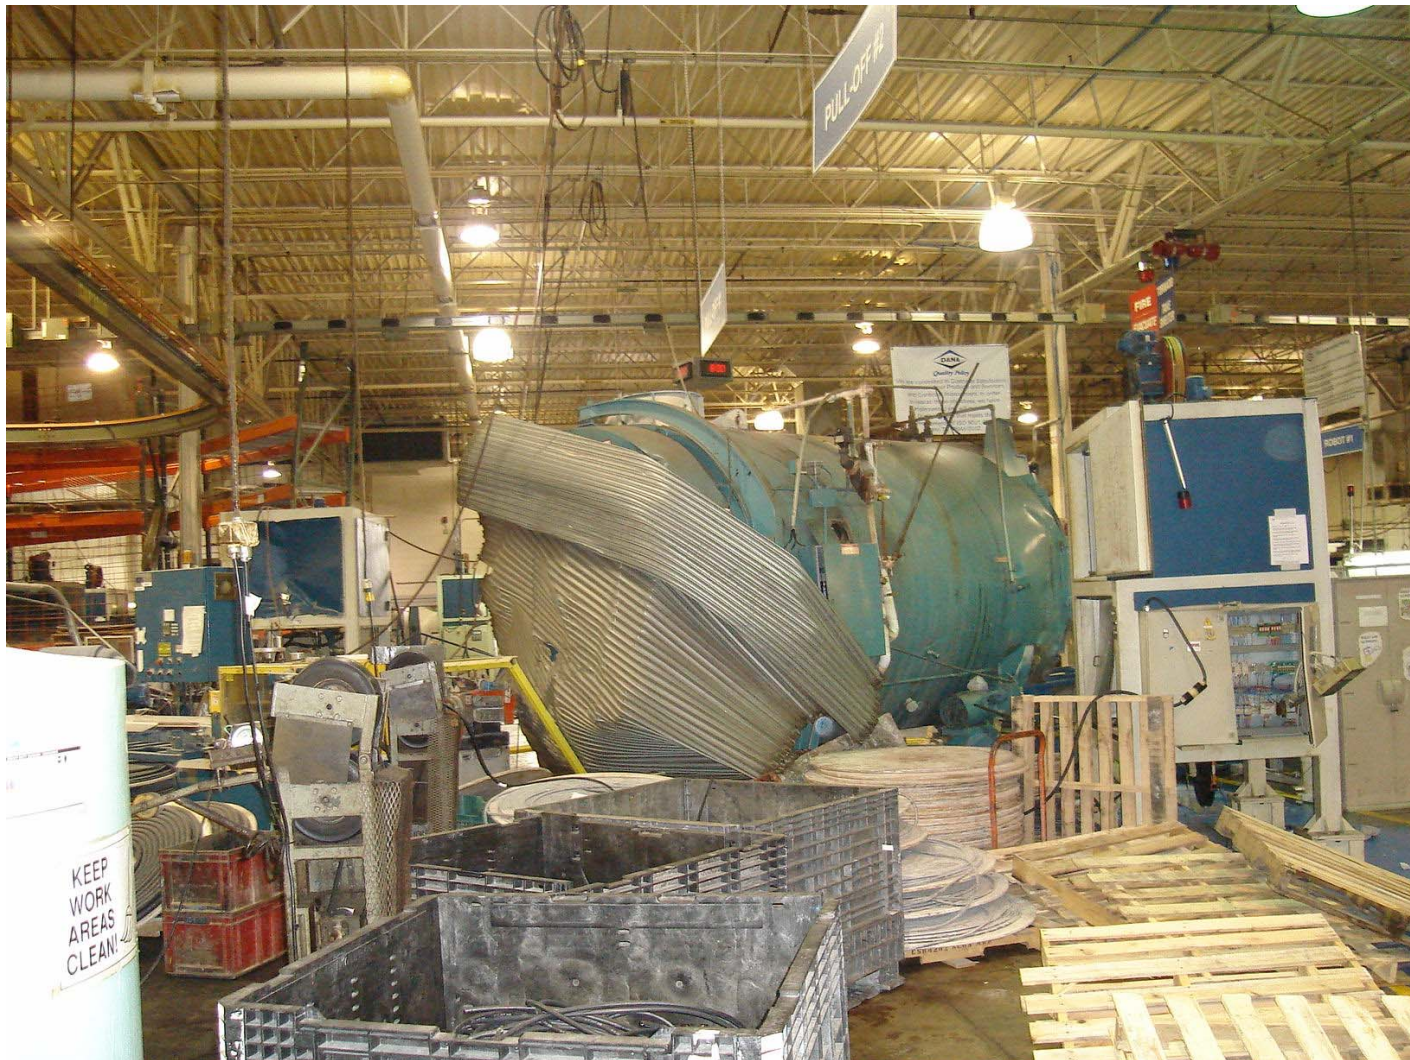
Shortly after Mr. Evans entered the boiler room, boiler #2 exploded, sending the boiler through the industrial roll up door, knocking down a portion of the wall and resting over one-hundred (100) feet from its original location into the center of the manufacturing room floor (see Photos #1, #2, #3, & #4). The explosion hurled the rear door of the boiler through the opposite cement block wall, creating a thirty (30) foot hole in the outer wall of the plant (see Photos #5 & #6). The rear door and debris damaged many vehicles in the parking lot, as well as a pedestrian walkway, before coming to rest in a ditch one-hundred (100) feet from the boiler room (see Photos #7 & #8). The internal south wall of the boiler room also collapsed during the explosion, causing additional damage to property and equipment (see Photo #9).

Photo #1 – Final Location of Boiler after Explosion (Roll Up Door on Boiler)

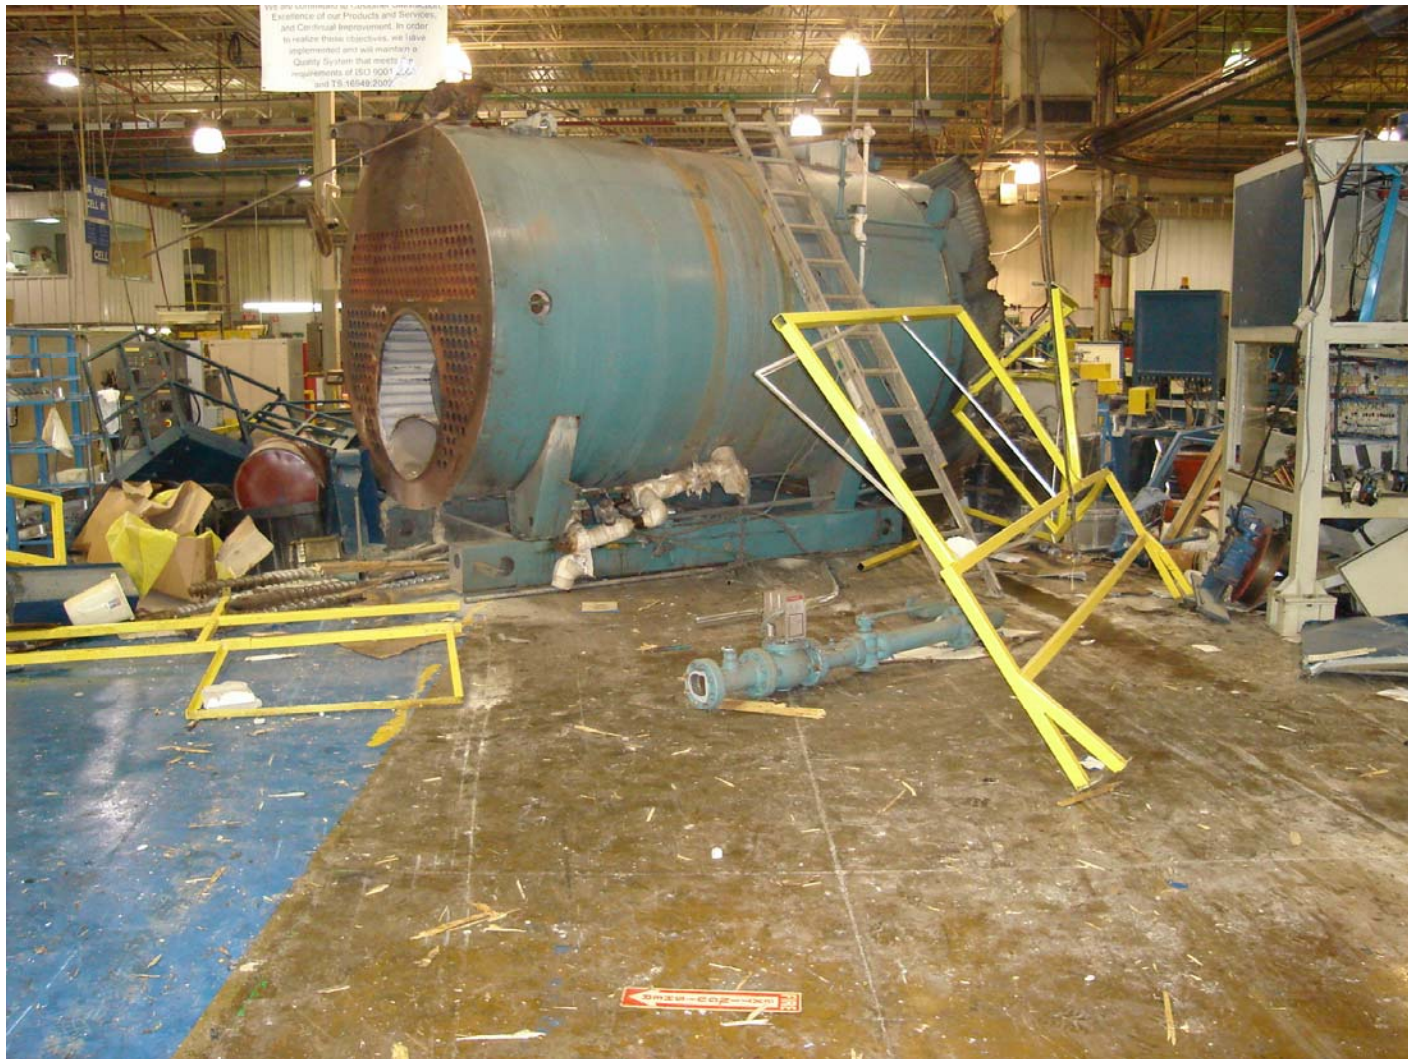
Photo #2 – Final Location of Boiler After Explosion

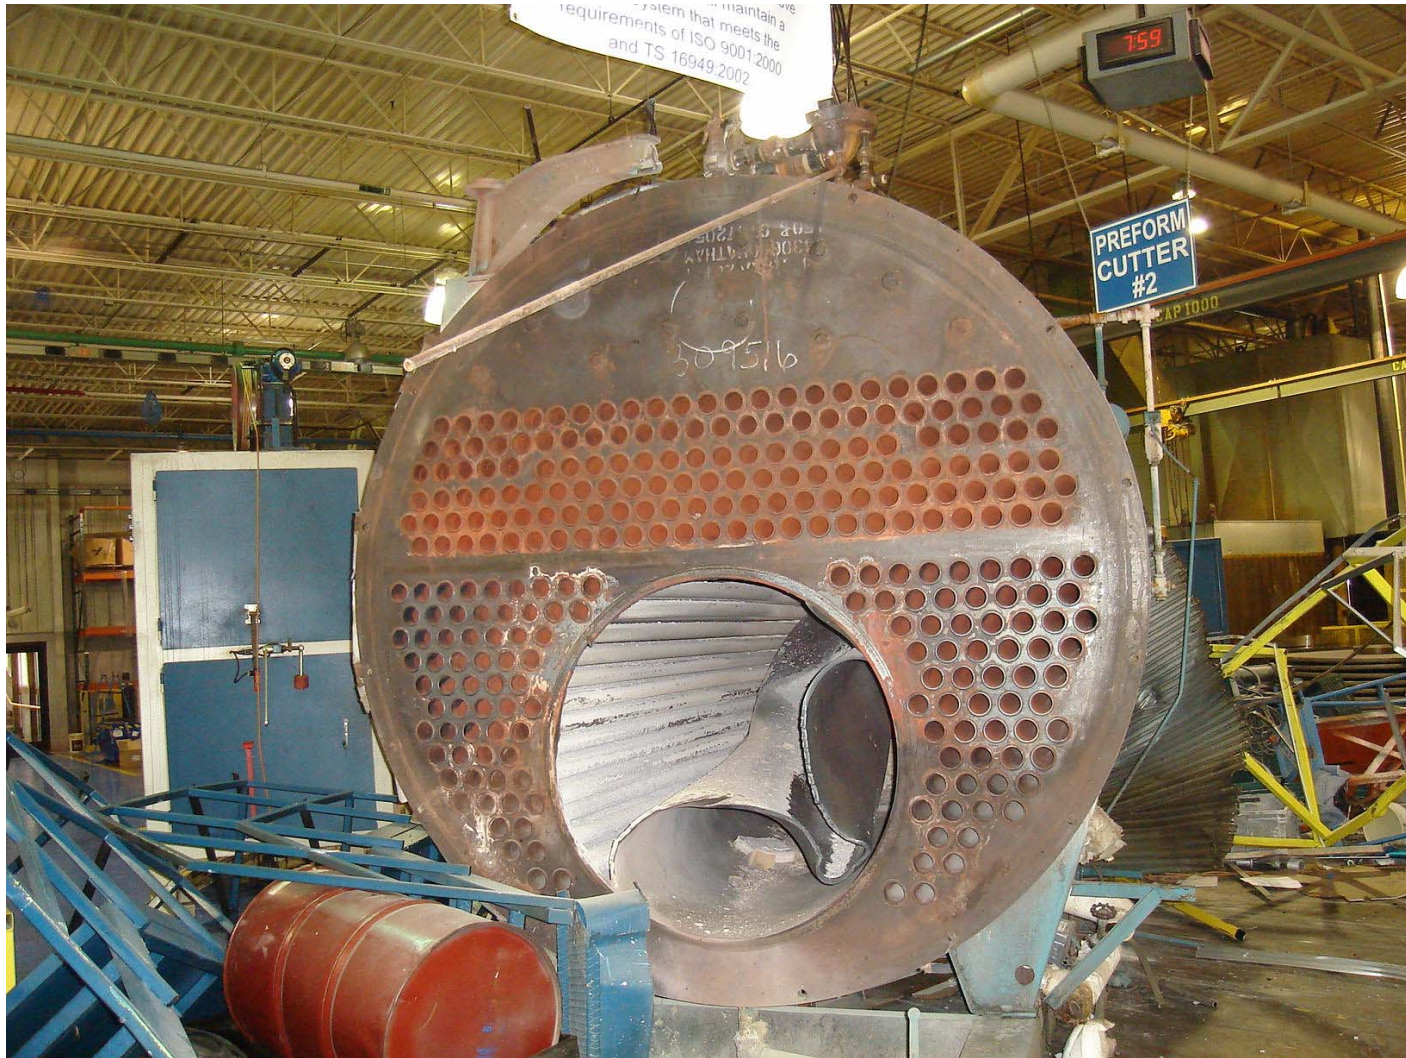
Photo #3 – Final Location of Boiler after Explosion (Exposed Furnace Tube)

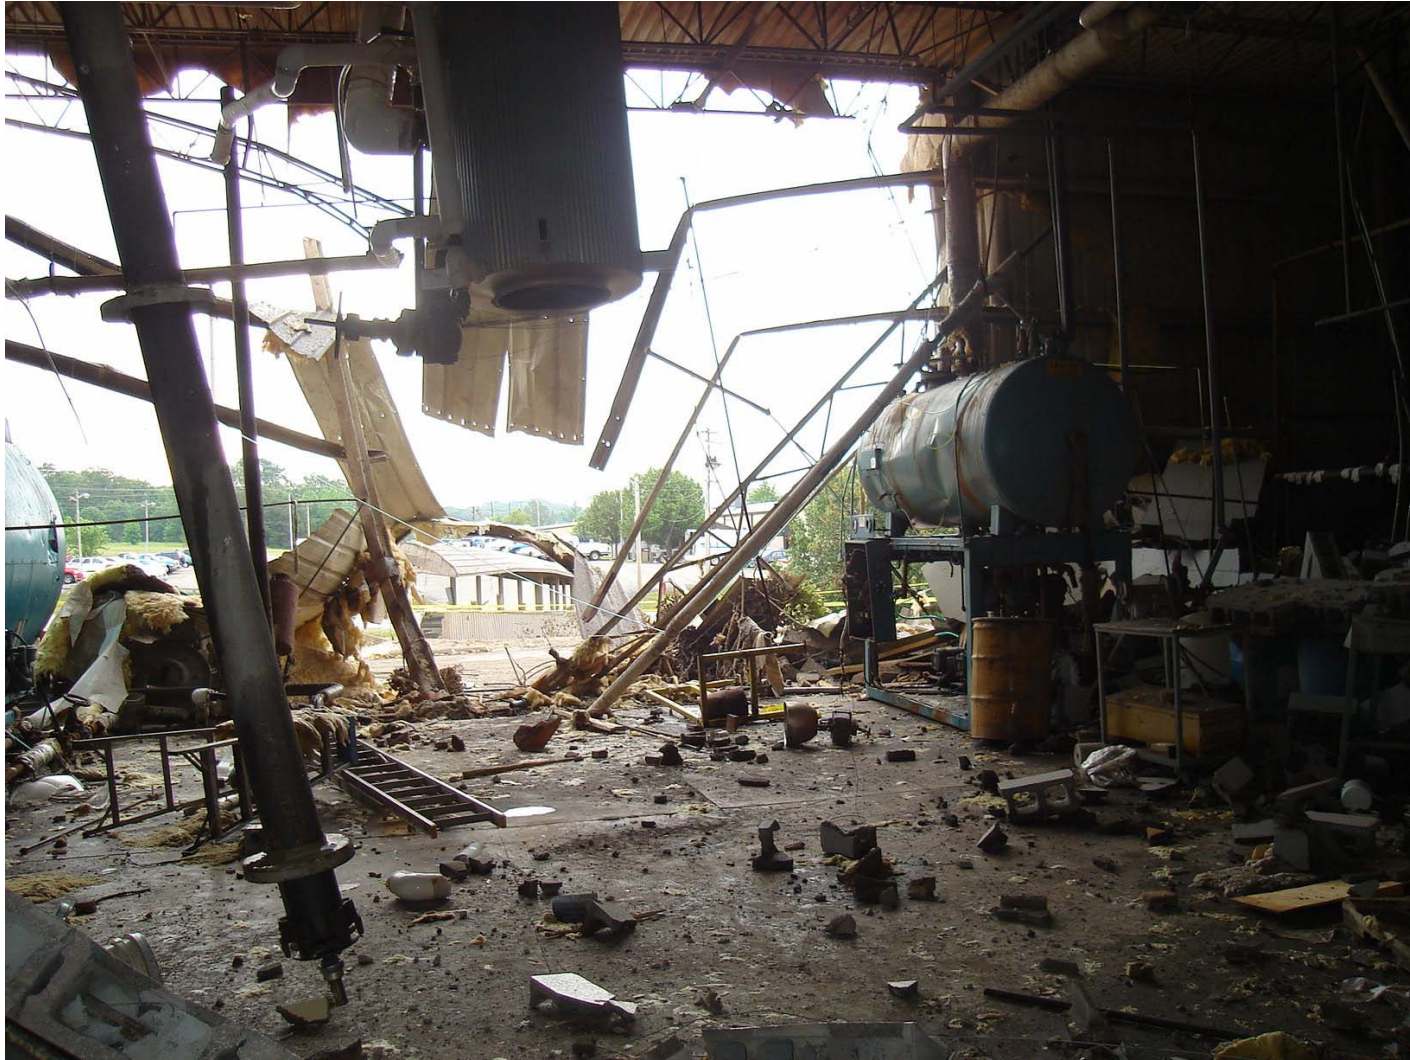
Photo #5 – Knocked Down Exterior Wall Viewed from Inside Boiler Room (East Wall)

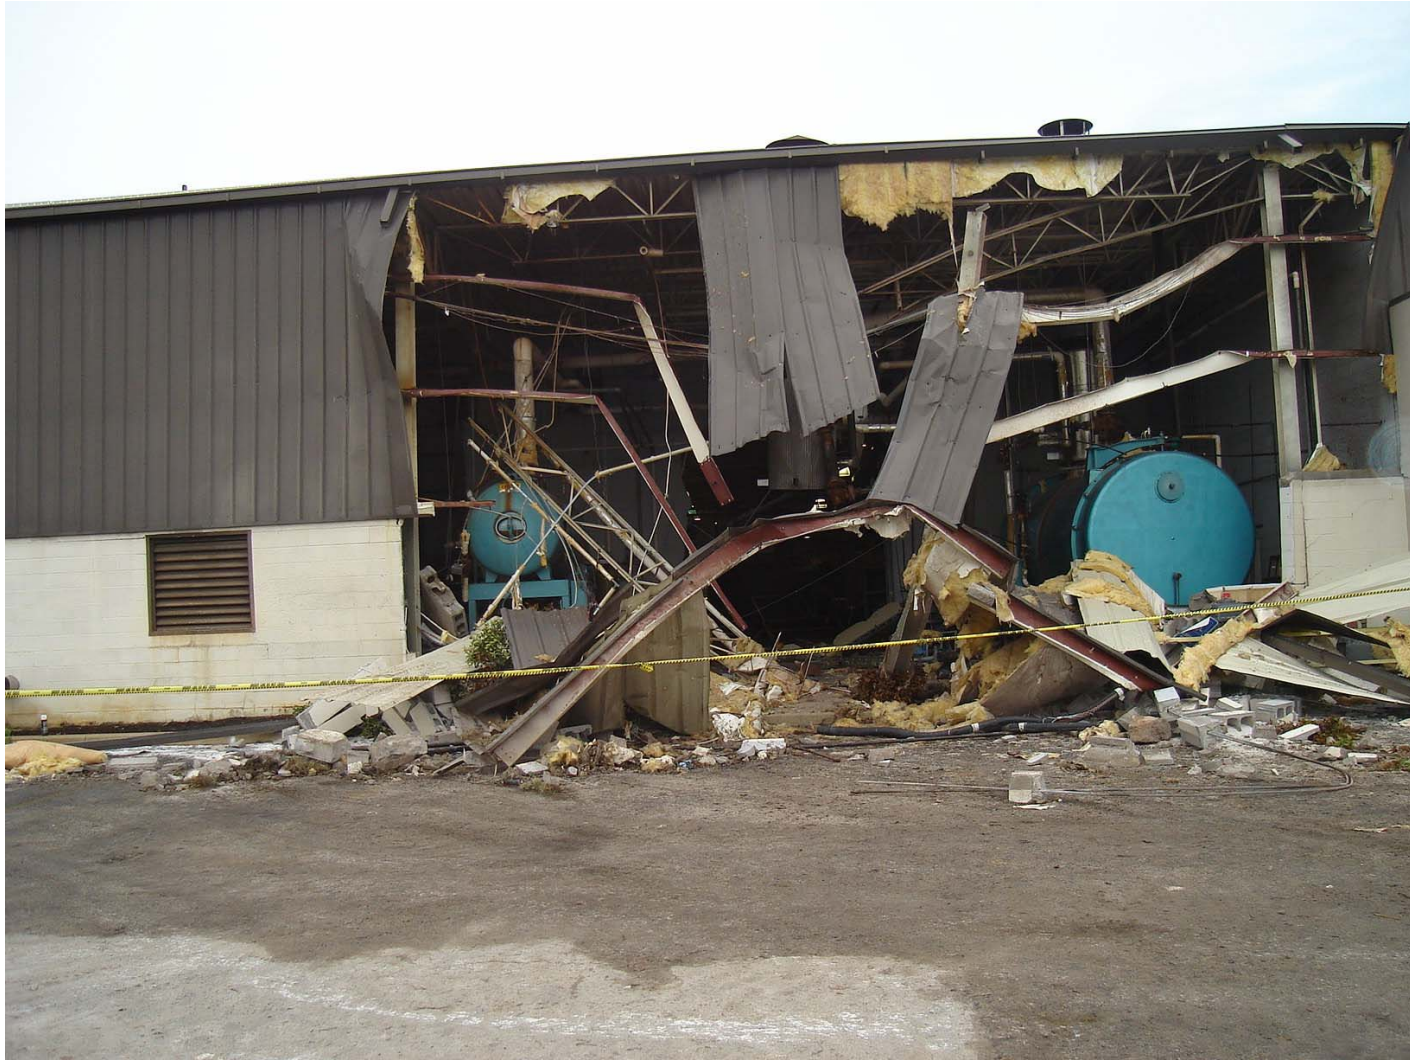
Photo #6 – View of East Wall from Outside Plant

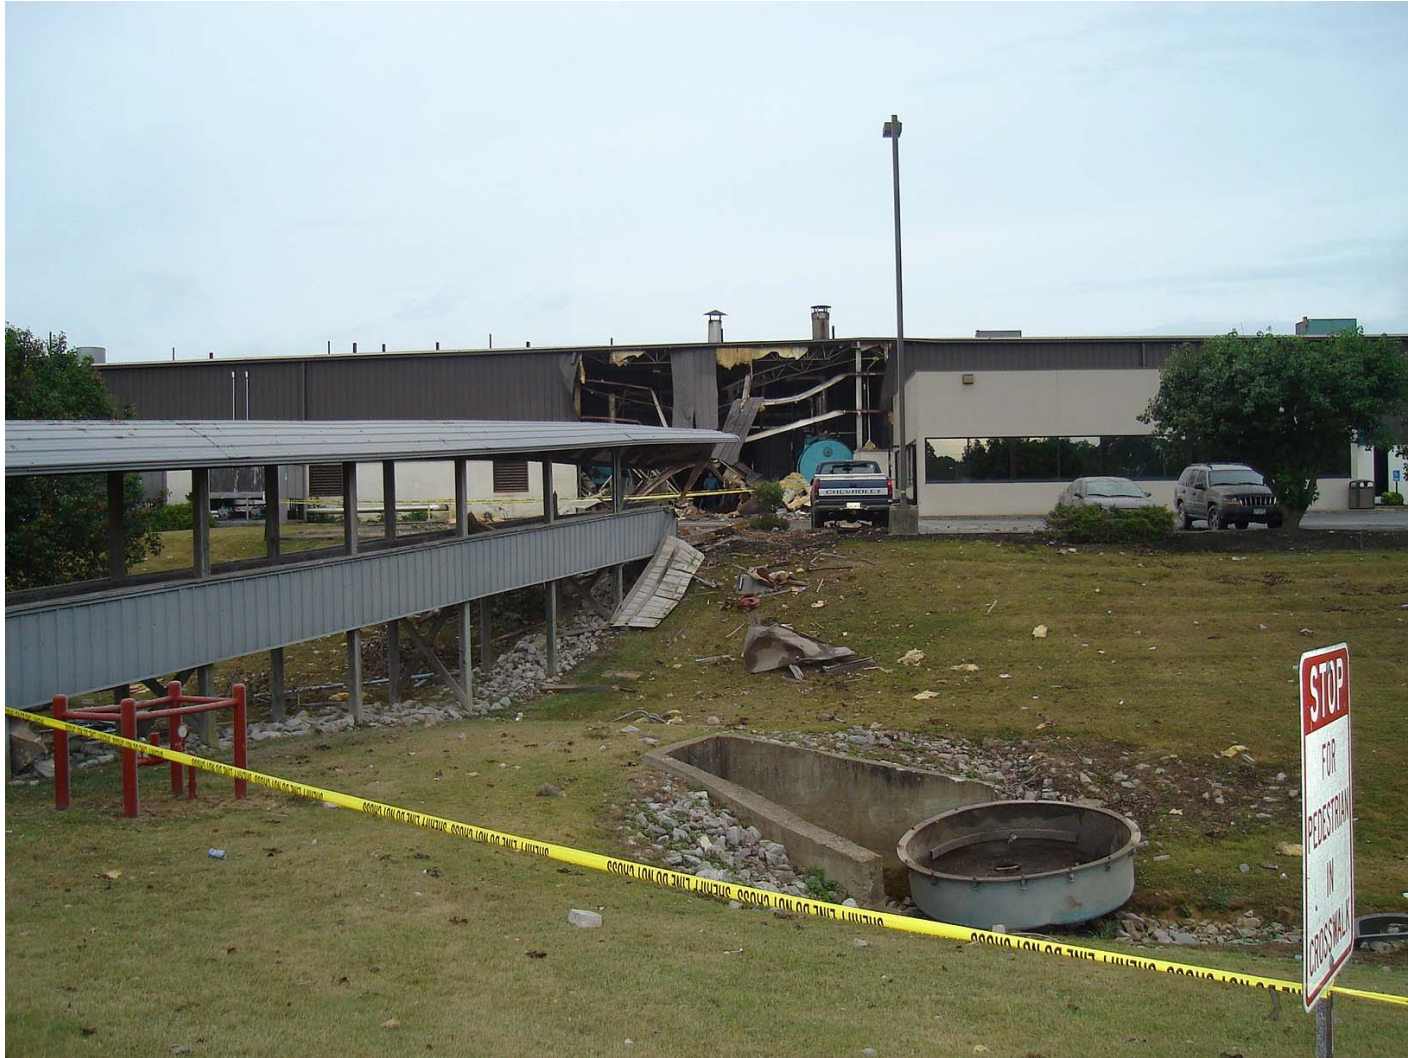
Photo #7 – View of East Wall from Outside Plant (Note Rear Boiler Door in Ditch)

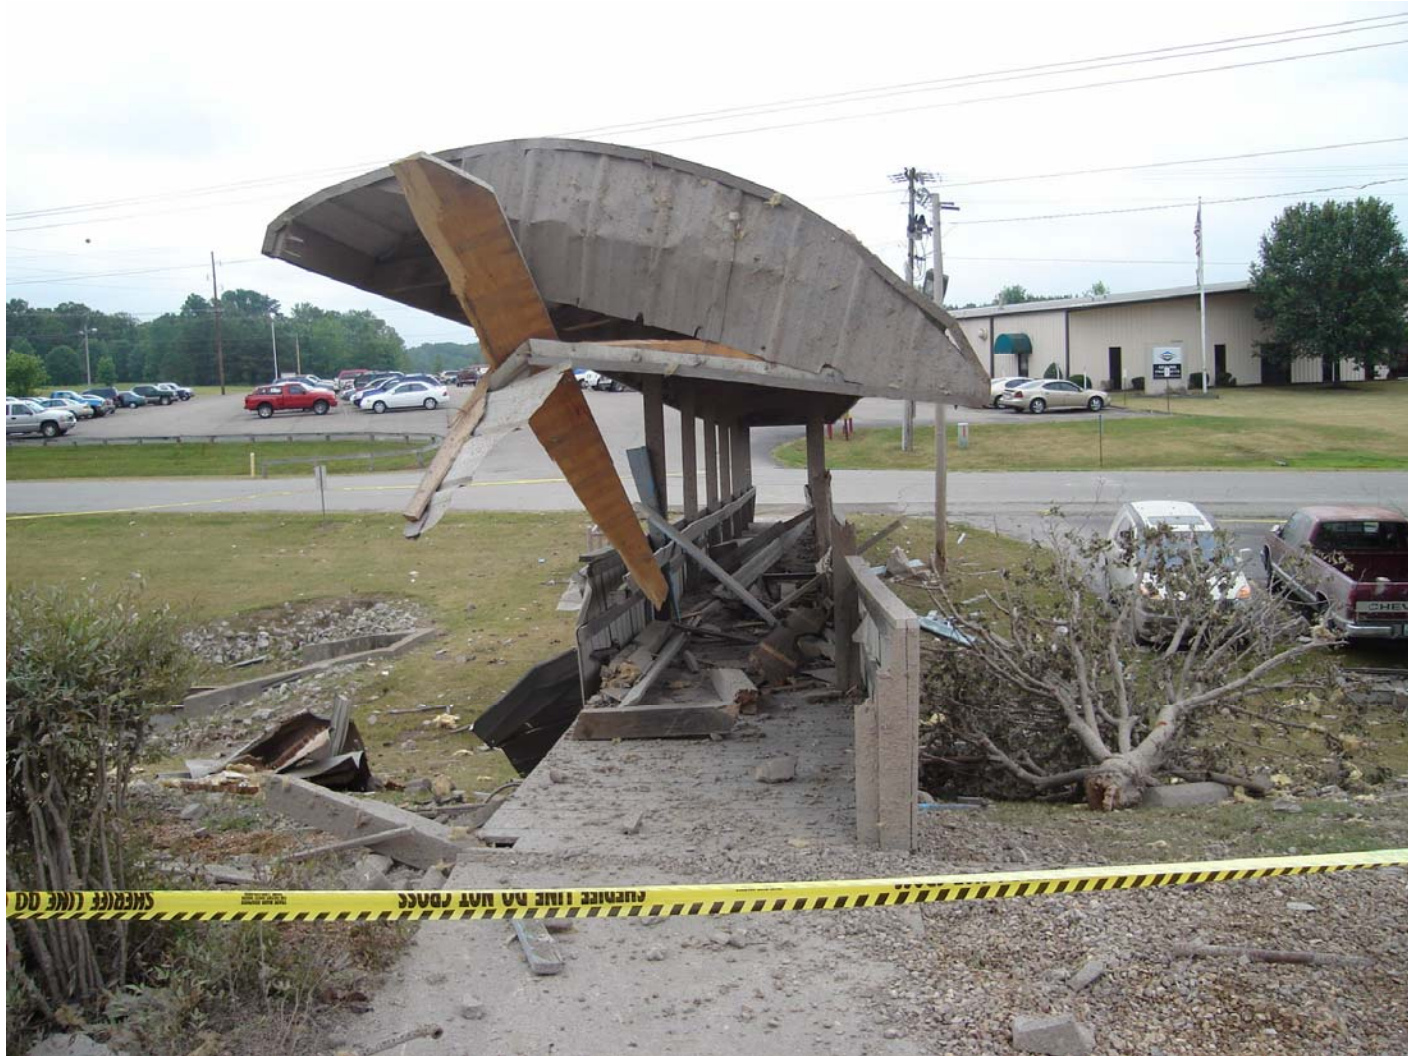
Photo #8 – View of Pedestrian Walkway Bridge

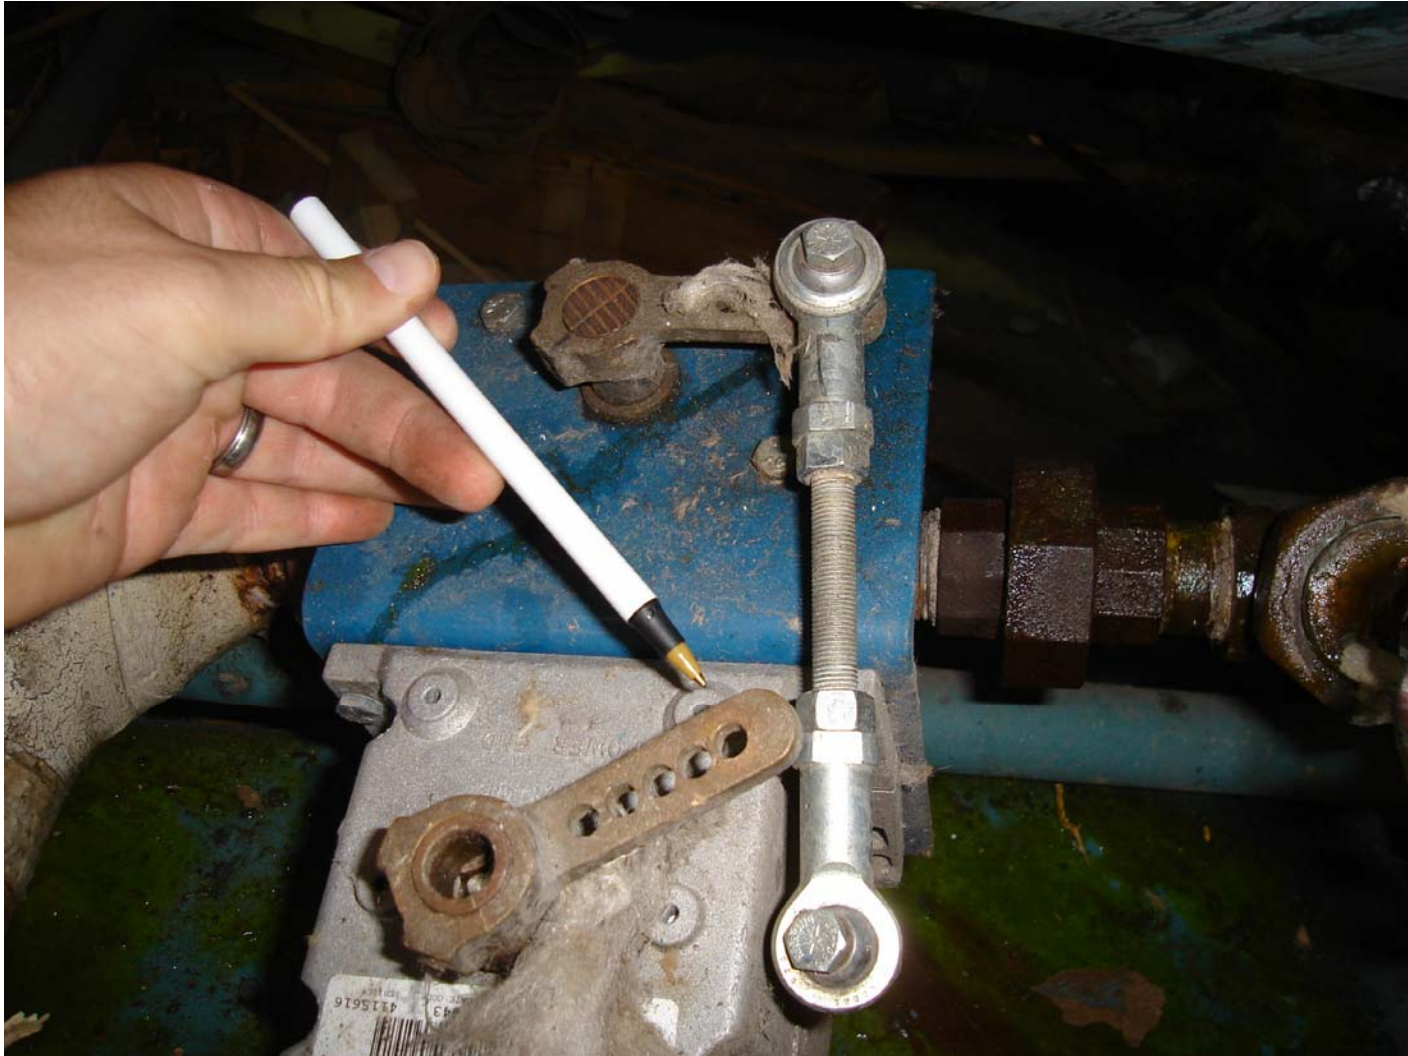
Due to the reoccurring high water condition (i.e., flooding), the decision was made by maintenance to disconnect the modulating feed controller (Honeywell) from the feed valve (Worcester ball valve) (see Photos #10 & #11). The disconnection of the controller arm was performed by Dana Corporation maintenance personnel. By disconnecting the modulating feed controller, the boiler operator would be required to throttle the feed valve to allow feed water to be introduced into the boiler. During the investigation, it was found that the bypass valve connected to the modulating feed valve had been opened halfway (see Photo #12).

3. The modulating feed controller was disconnected from its feed valve (see Photos #10 & #11). *The feed system for the boilers is a continuous system, which means the feed pumps operate constantly and the modulating feed valve opens and closes per the demand of the boilers for feed water. The operation of the modulating feed controller is controlled from the M&M controller.*

Photo #10 – Modulating Feed Controller, Valve, and Bypass (Note Disconnected Operating Arm)

Photo #11 – Modulating Feed Controller and Valve with Disconnected Operating Arm

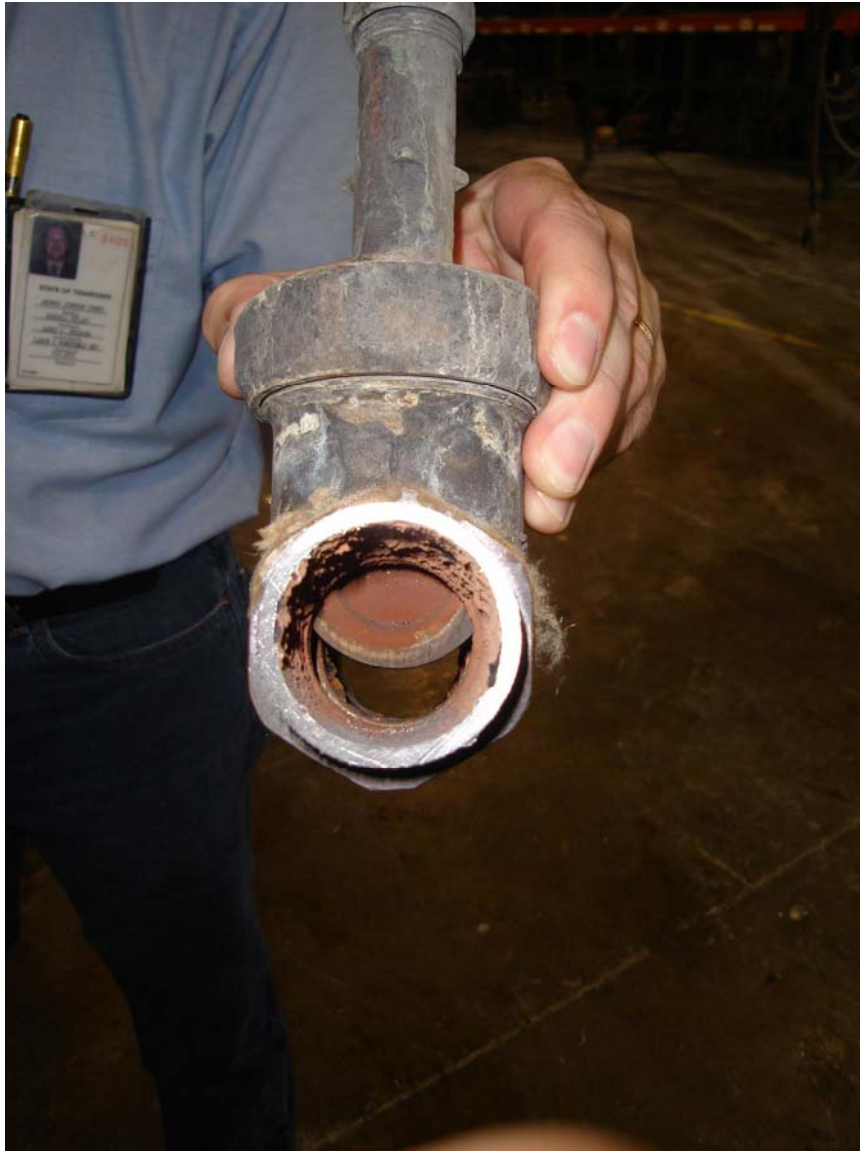
4. The modulating feed valve bypass was opened approximately halfway. This shows evidence of throttling the feed water inlet that in essence bypassed the modulating feed valve (see Photo #12).

Since the modulating feed valve bypass was opened halfway, the boiler water level would have fluctuated as the boiler fired, causing the primary LWCO to operate more as a control than a safety device. This could account for the need to remove the required manual reset on the auxiliary LWCO. With the feed valve bypass open, there would be no automatic control of the amount of feed water that enters the boiler. This could account for the high-water conditions. On the other hand, if the boiler calls for more feed water than what is delivered through the opened bypass, the boiler would subsequently go to a low-water condition; because of the manual reset, maintenance personnel would be required to manually reset the boiler in the boiler room. By removing the relay with the manual reset with one that is automatic, once the boiler water reaches a safe level, the boiler will begin to fire without any interaction from maintenance personnel. This is not allowed per the Code. (Ref. CSD-1, CW-140)

Photo #12 - Bypass to the Modulating Feed Valve. Valve was found in the half open position.

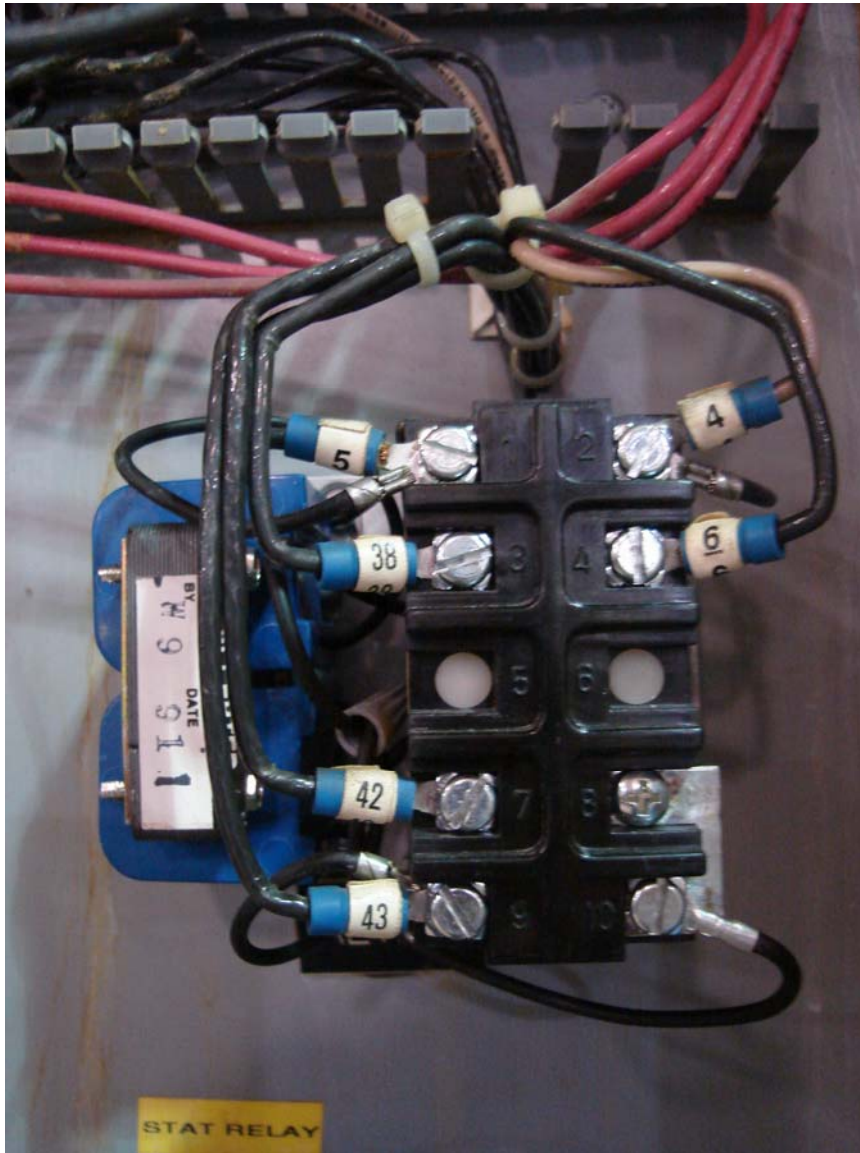
5. An improper relay (1d1d0) for the auxiliary low-water cutoff was installed by Dana Corporation maintenance personnel (see Photo #15). Due to a dissimilar connect configuration, the different wire line-up caused the circuit to remain closed, which gave a misreading of the boiler water level. Since the circuit was continuously closed, no matter if water was in the boiler or not, the safety device would read that the water level was at a safe operating level. Photos #16a and #16b illustrate the 1c1d0a and 1d1d0 relays. The 1c1d0a is the proper relay for the boiler in question; 1d1d0 was the improper relay that was installed by Dana Corporation maintenance personnel. Note the different contact configuration diagrams.

Given that the auxiliary LWCO relay was replaced with the incorrect model, the primary LWCO did not respond and cut-off the fuel supply to the boiler, the boiler continued to fire until the accident occurred. Without corroboration, it can only be speculated that operation of the boiler's

Photo #15 – Improper relay that was installed by Dana Corporation maintenance personnel for the Auxiliary LWCO

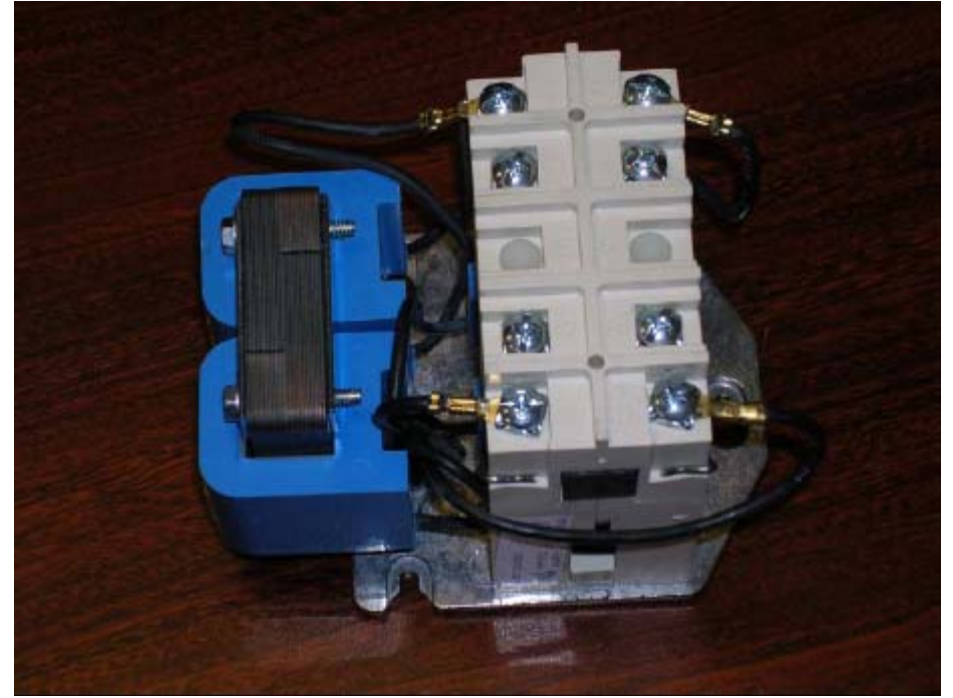
6. The manual reset for the auxiliary low water cut-off was removed when the improper relay was installed. On the Cleaver-Brooks CB Packaged Boiler, the auxiliary LWCO is intended to be installed with the Code required manual reset switch. Photo #17a illustrates the proper relay that should have been installed, Note the manual reset button and compare with Photo #17b that has no manual reset.

Photo #17a –1c1d0a (Proper Relay with Manual Reset)

Photo #17b – 1d1d0 (Improper Relay without Manual Reset)
